FRC ON-SITE AIR BAG DEPLOYMENT INVESTIGATION

CASE NO. 90-16

FLEET - 1987 MERCEDES-BENZ 300DT

ACCIDENT DATE - [REDACTED], 1990

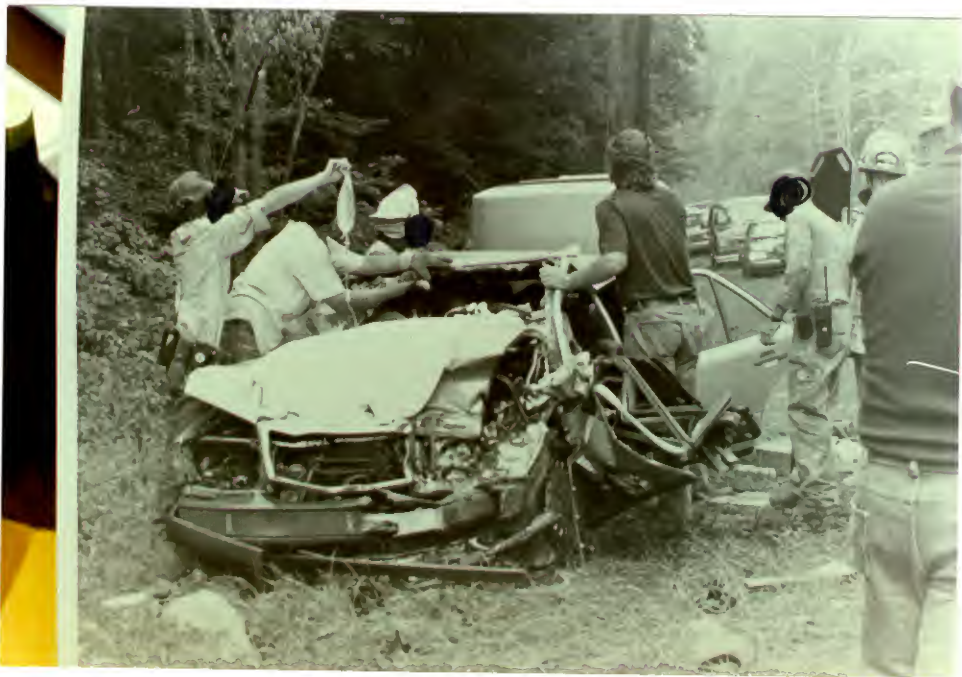
Final Rest Position And Damage To The Mercedes-Benz

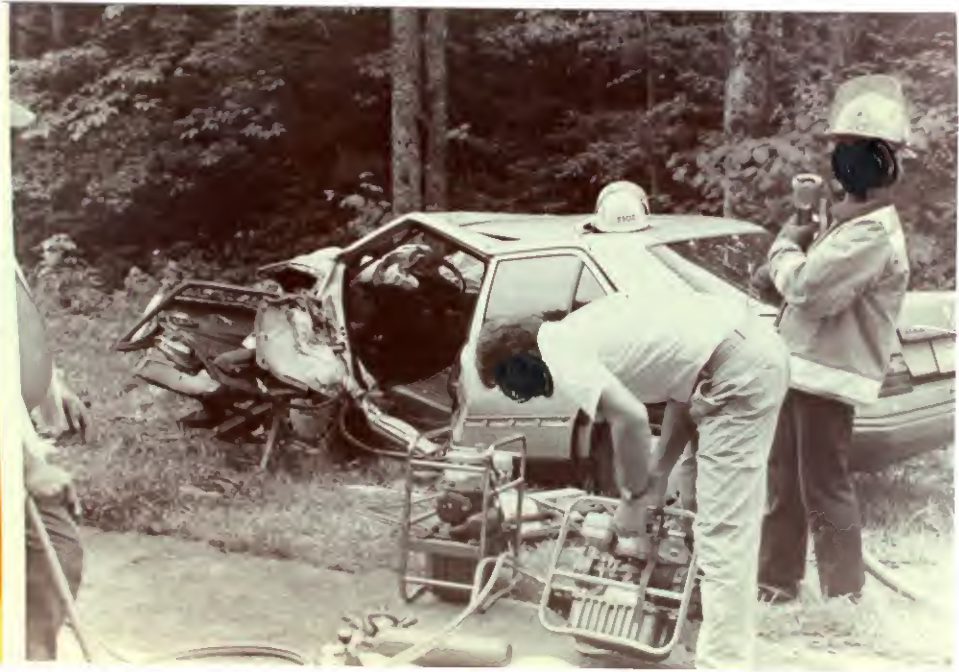
Left Side View Of The Mercedes-Benz At Final Rest

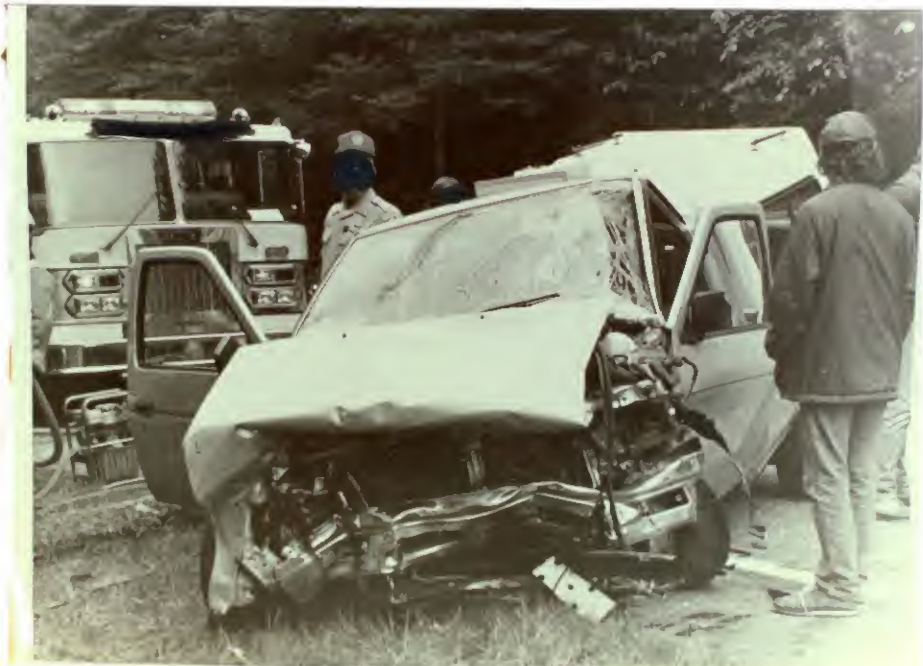
The 23-year-old driver of the Nissan pickup truck was reportedly restrained by the active 3-point lap and shoulder belt system. He loaded the belt webbing and the intruding steering column that resulted in internal abdominal injuries. He was admitted to a [REDACTED] for treatment of his injuries.

Frontal View Of The Damaged Pickup Truck

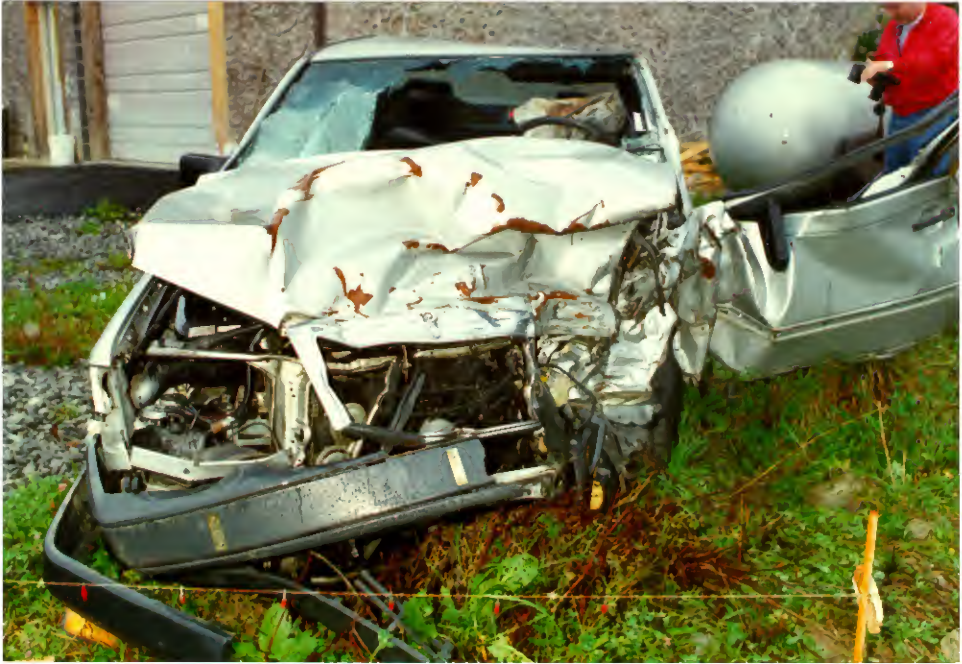
<u>Air Bag Vehicle</u>	<u>Vehicle #2</u>
Exterior:	<p>The frontal area of the Mercedes-Benz sustained severe damage from its impact with vehicle #2. Direct contact damage began at the left front corner and extended 31" to the vehicle's right. The impact displaced the entire frontal area of the vehicle resulting in a combined induced and direct contact damage length of 41". Maximum crush was 33.75" located at the left corner of the bumper reinforcement bar. Crush values measured at the reinforcement bar were as follows: C₁=33.75", C₂=20.25", C₃=14.5", C₄=6.5", C₅=1.875", C₆=1.0".</p>	<p>Primary - The frontal area of the Nissan pickup truck sustained severe damage from its head-on impact sequence with the Mercedes-Benz. Although the vehicle was not inspected, the crush profile was estimated as follows: C₁=42", C₂=36", C₃=30", C₄=18", C₅=12", C₆=8".</p> <p>Secondary - The left front corner initially sideswiped the left side of vehicle #3. The damage was overlapped by the primary impact damage from the air bag vehicle.</p>

Frontal View Of The Mercedes-Benz

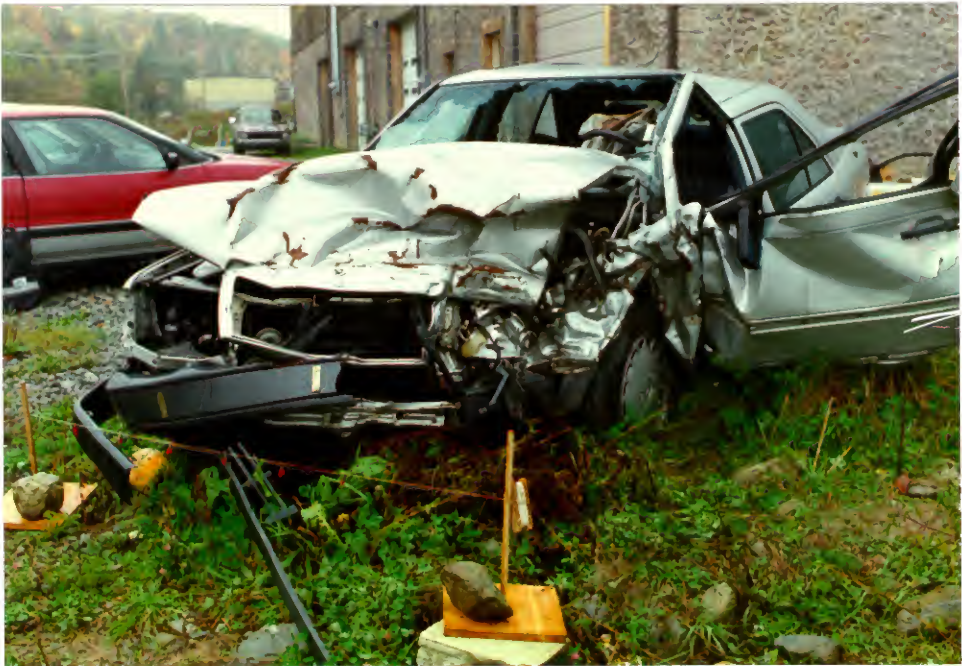
<u>Air Bag Vehicle</u>	<u>Vehicle #2</u>	
Exterior (Cont'd.):	<p>Components damaged by the crash included the front bumper facia and filler panel, grille, hood, both headlight assemblies, left front fender, left A-pillar, roof, left front door and the unibody chassis.</p> <p>The left wheelbase was reduced in size by 21.7" while the right was lengthened by 1.0".</p>		
CDC:	12-FYEW-3	Primary - 01-FDEW-4 Secondary - 12-FLEE-3 (estimated)	<u>Object Struck</u> Air Bag Vehicle Vehicle #3
Repair Cost:	Total loss	Total loss	
Interior (Air Bag Vehicle):	<p>The interior of the Mercedes-Benz was reduced in size by intrusion of numerous components. Maximum intrusion involved 15.7" of rearward displacement of the left toe pan. Additional intrusions involved rearward displacement of the left lower A-pillar and left instrument panel (8.5"). The steering column was displaced rearward 2.5" while it rotated upward and to the left approximately 1.5". The compression of the left passenger compartment displaced the rear floor pan upward 4.5" on the left and 3.0" on the right side.</p> <p>The driver's left knee contacted the intruding knee bolster 14-22" left of the vehicle's centerline. The 8" diameter contact deformed the padded component to a depth of 2.4". Her face loaded the deployed air bag near the center of the bag. A lipstick transfer was located on the air bag .75" - 3" right of center and 1.75" - 3.5" above the horizontal centerline. A 6" diameter makeup transfer surrounded the lipstick transfer. The air bag contact caused a nose bleed to the driver which resulted in a large blood stain to the lower left quadrant of the air bag. The driver rebounded into the seatback and head restraint; however, no damage or contact evidence was visible to these components.</p>

Left Front Three-Quarter View

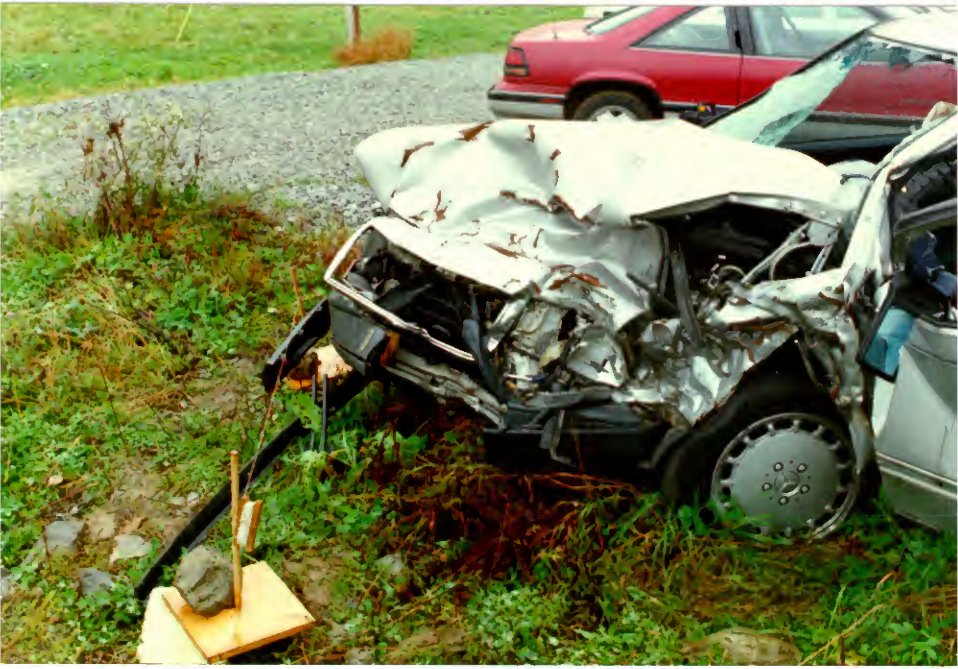
The frontal area of the Nissan pickup truck impacted the left frontal area of the Mercedes in an offset, head-on configuration. The Mercedes sustained 33.75" of crush at the left corner of the bumper reinforcement bar from the 12 o'clock direction of force impact (PDOF: -15°). A velocity change of 26.8 mph was computed by the damage algorithm of the CRASHPC program. As a result of the impact induced deceleration, the Mercedes' SRS system deployed.

Perpendicular View Of The Left Frontal Area Showing
The Extent Of Crush

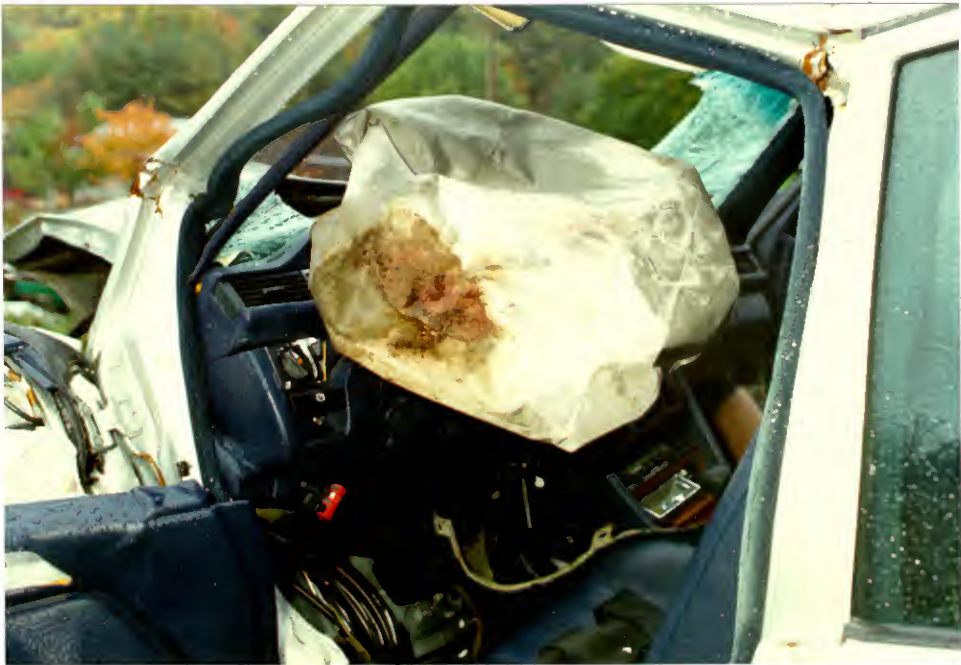
Interior View And The Deployed Air Bag

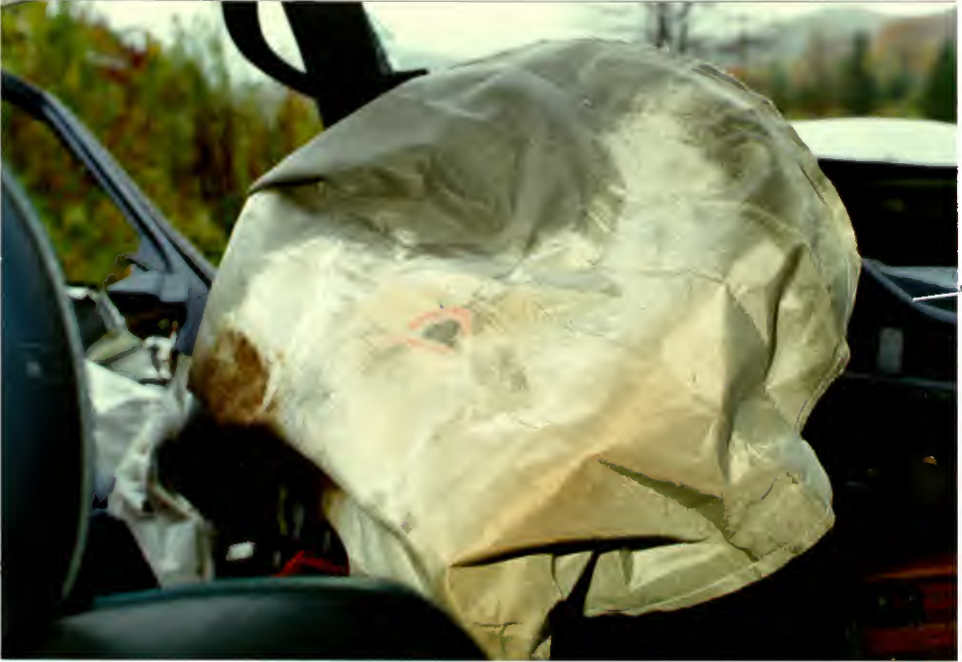
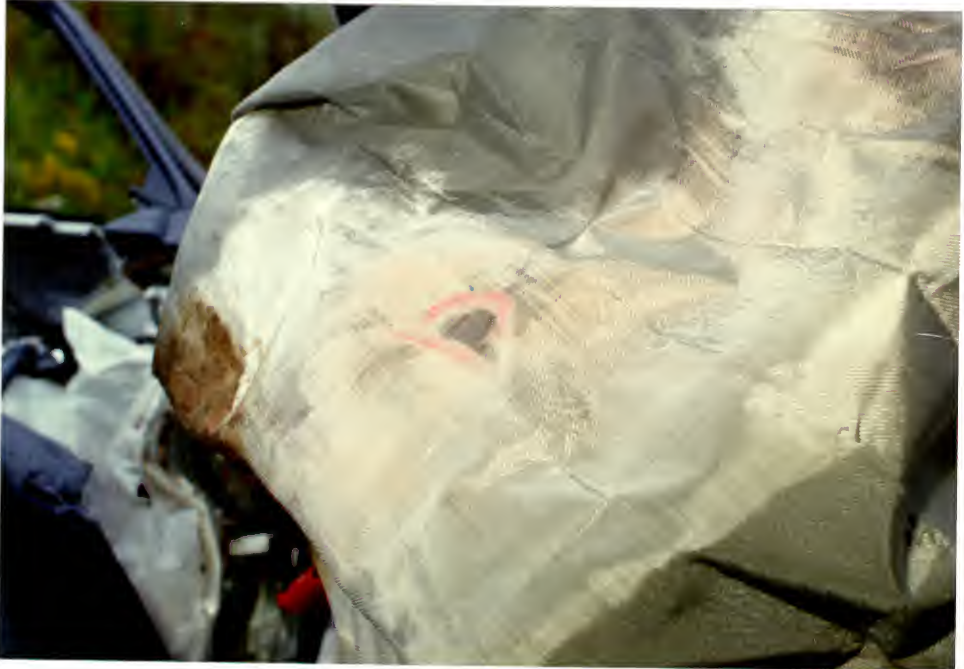
Lipstick And Makeup Transfers On The Deployed Air Bag

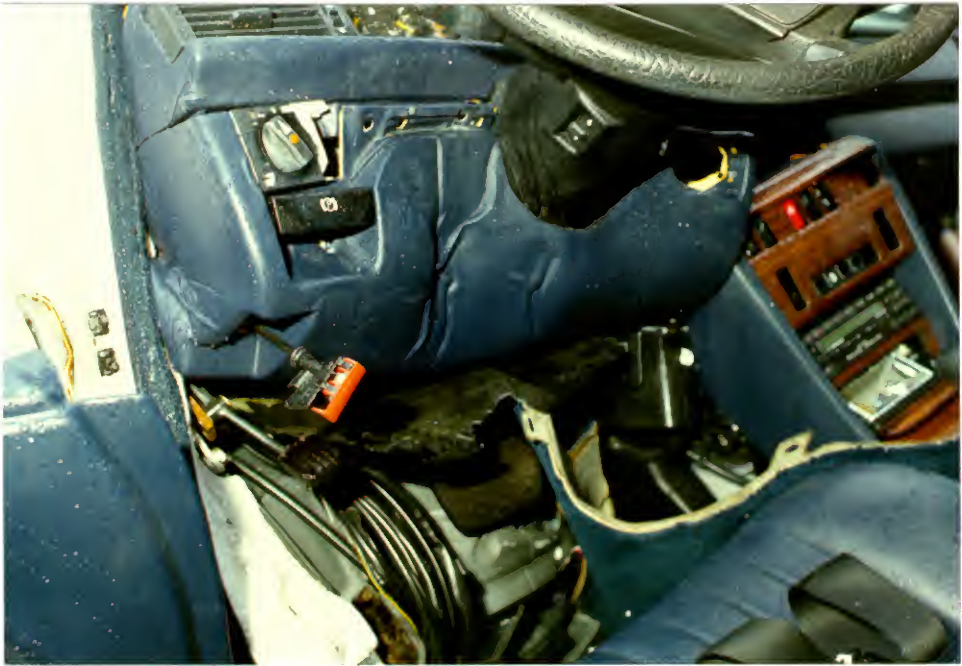
Driver Left Knee Contact To Knee Bolster

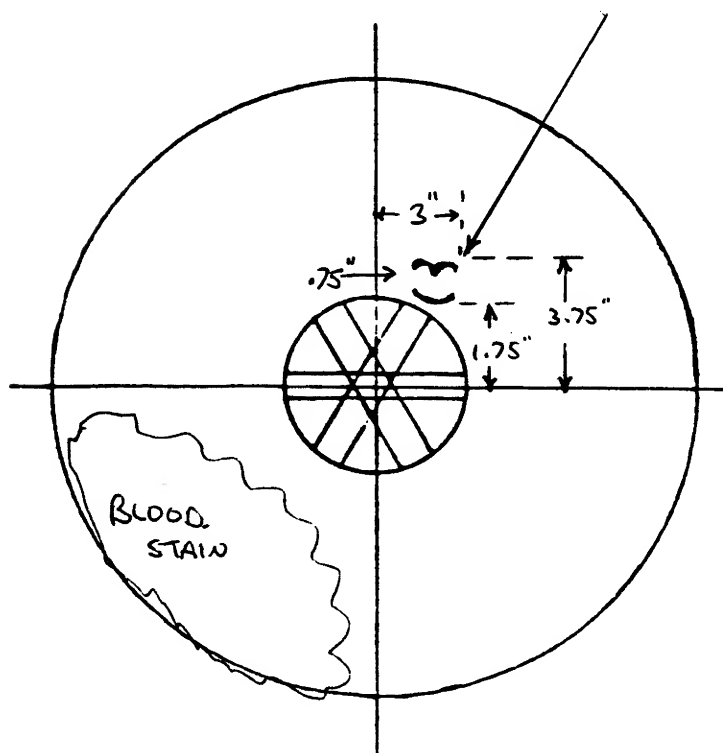
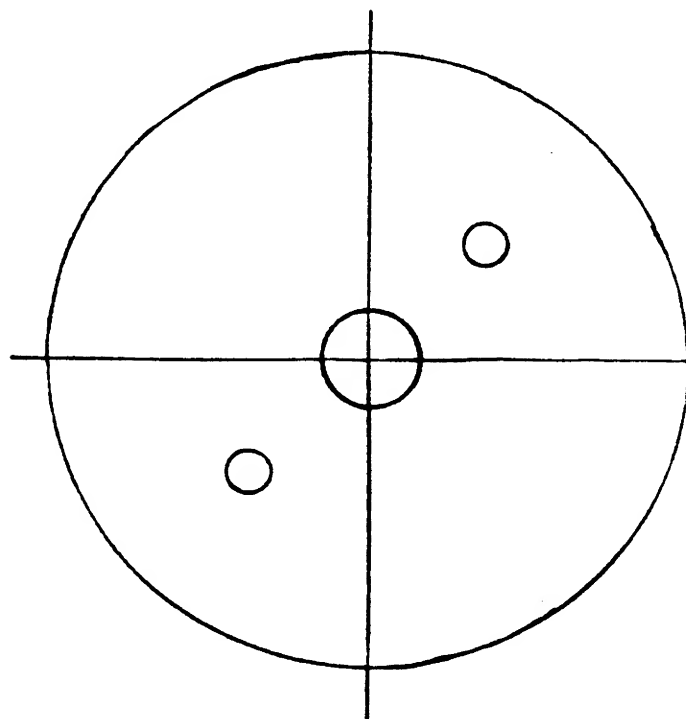
LIP STICK TRANSFER
